Cornerstone Home Inspections & Consulting

Property Inspection Report

, Sugar Land, TX 77459 Inspection prepared for: Real Estate Agent: -

Date of Inspection: 7/21/2015 Time: 8:00 AM Age of Home: 11years old Size: 4,406 sq.ft. Weather: Clear, Hot

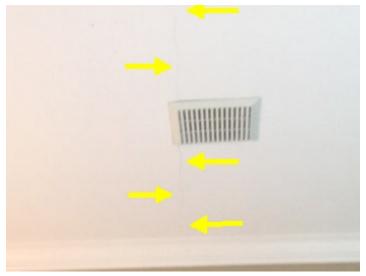
Crack in master bathroom ceiling. Cosmetic

STRUCTURAL SYSTEMS			
Page 3 Item: E		Paint is weathered on exterior in places. Crack in master bathroom ceiling	
Page 4 Item: J		Fireplace damper is required to have a block on the damper door to prevent closing.	
Page 5 Item: L	Other	Privacy fence on east side of home is leaning

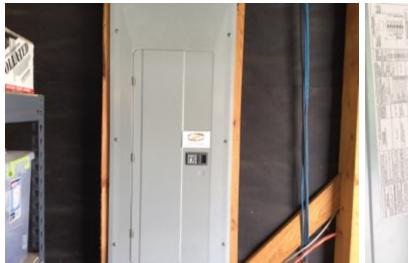
Breaker panel

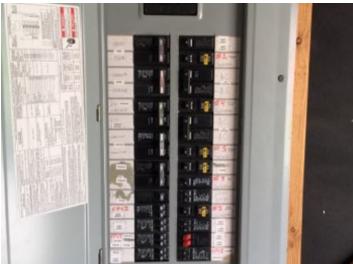
Panel is properly marked

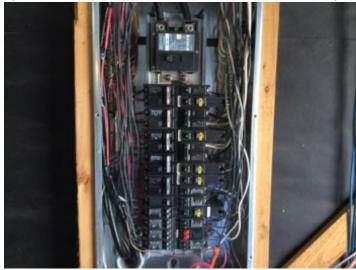
Interior of breaker panel

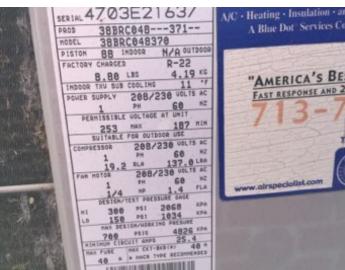
Condensing unit data plate

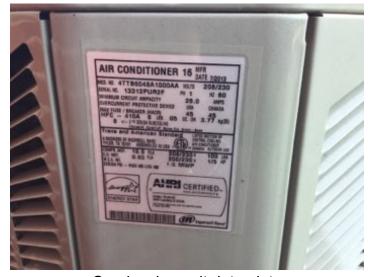
Condensing unit data plate

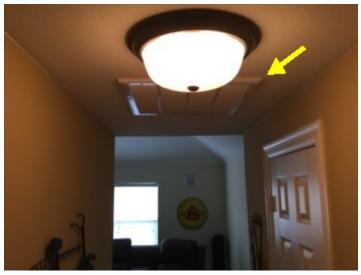
Return air grill located in hall ceiling going to media room. 20 X 20 filter

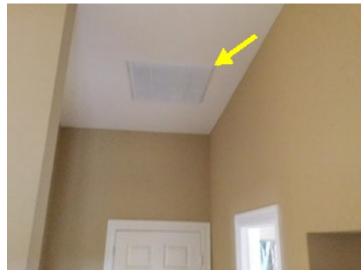
Return air grill in hallway ceiling by stairway. 20 X 20 filter

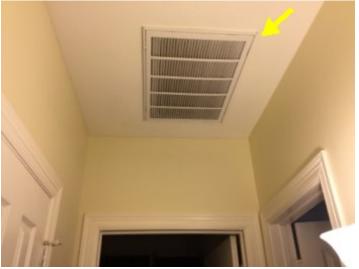
Downstairs return air grill. 16 X 20 filter

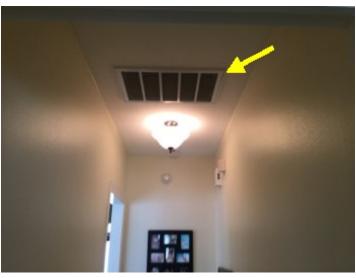
Master bedroom hallway return air grill. 16 X 20

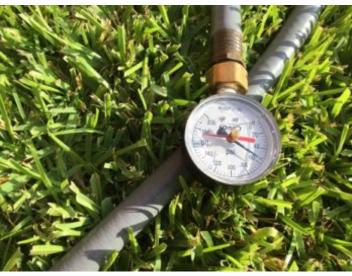
Static water pressure

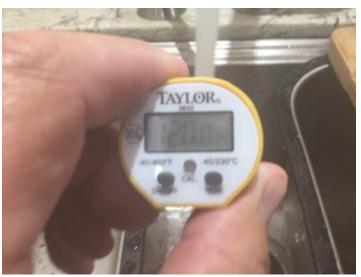
Water temperature at kitchen sink, 120 *F
