Cornerstone Home Inspections & Consulting

Property Inspection Report

, Sugar Land, TX 77459 Inspection prepared for: Real Estate Agent: -

Date of Inspection: 7/21/2015 Time: 8:00 AM Age of Home: 11years old Size: 4,406 sq.ft. Weather: Clear, Hot

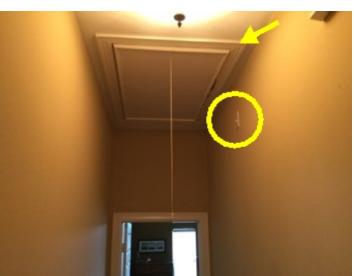
Attic access. Attic light switch
